**CRACKING OF MASONRY VENEER AROUND WOOD COLUMNS****WHY DOES IT CRACK?**

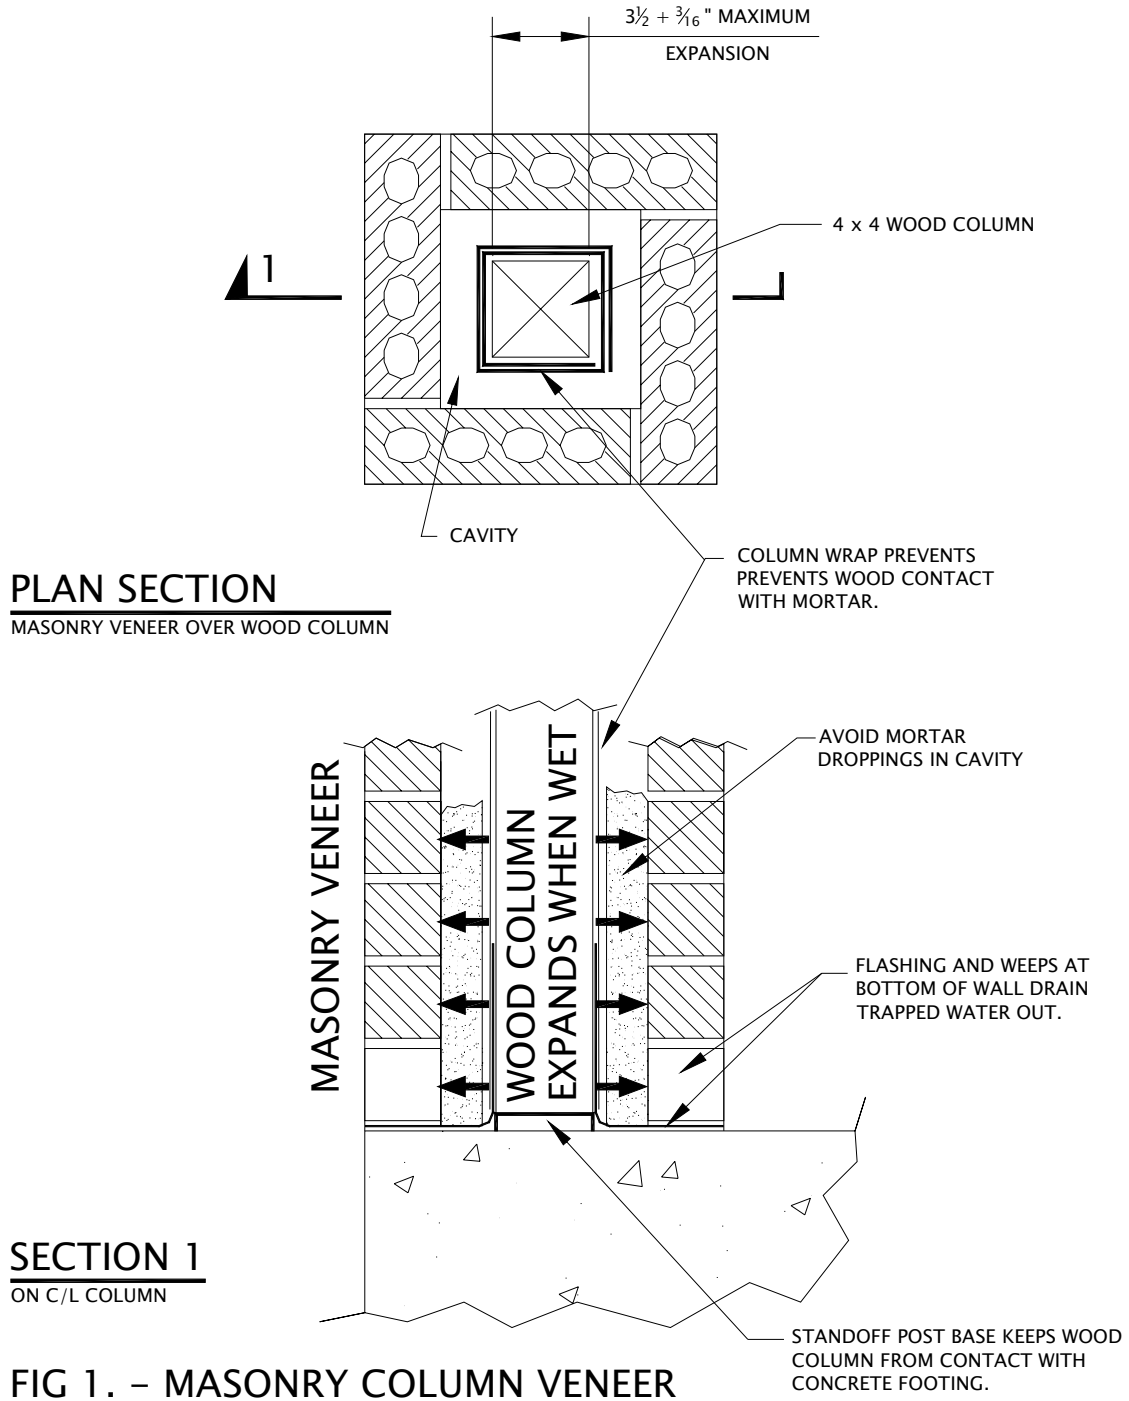
**FIG 1. – MASONRY COLUMN VENEER**

Home builders often encase wood columns supporting porches or overhangs on homes with brick or other masonry veneers. Sometimes the masonry veneer will split, leaving a vertical crack near the base of the column. Usually these cracks occur because mortar droppings have fallen into the cavity and filled the space between wood and masonry. As wood absorbs moisture, it expands in both horizontal directions (tangential and radial.) If there is no air space or compressible material, expanding wood will split masonry. (See Fig. 1) Also, wood columns often twist and warp, which makes the splitting worse.

Wood commonly used in construction expands about 10% from oven dry to saturated in the tangential direction. Most lumber used on the jobsite will have at least 15% moisture content, so a realistic total expansion is about half that, or 5%. This means that a 4x4 column will expand about 3.5" x 0.05 or 3/16". .

1. Set wood column on a Simpson AB series (or equal) metal post base to keep column base dry.
2. Install flashing all around the column at the base, including corners. Provide at least two weep holes at bottom to drain away excess water.
3. Wrap column with tarpaper or Tyvek full height. This keeps any mortar from contact with wood.
4. Keep the cavity clean and free of mortar. Placing products such as Mortar Net at the bottom of the column per manufacturer's instructions may help prevent mortar build-up.
