SUBJECT: Face Cracks on Brick

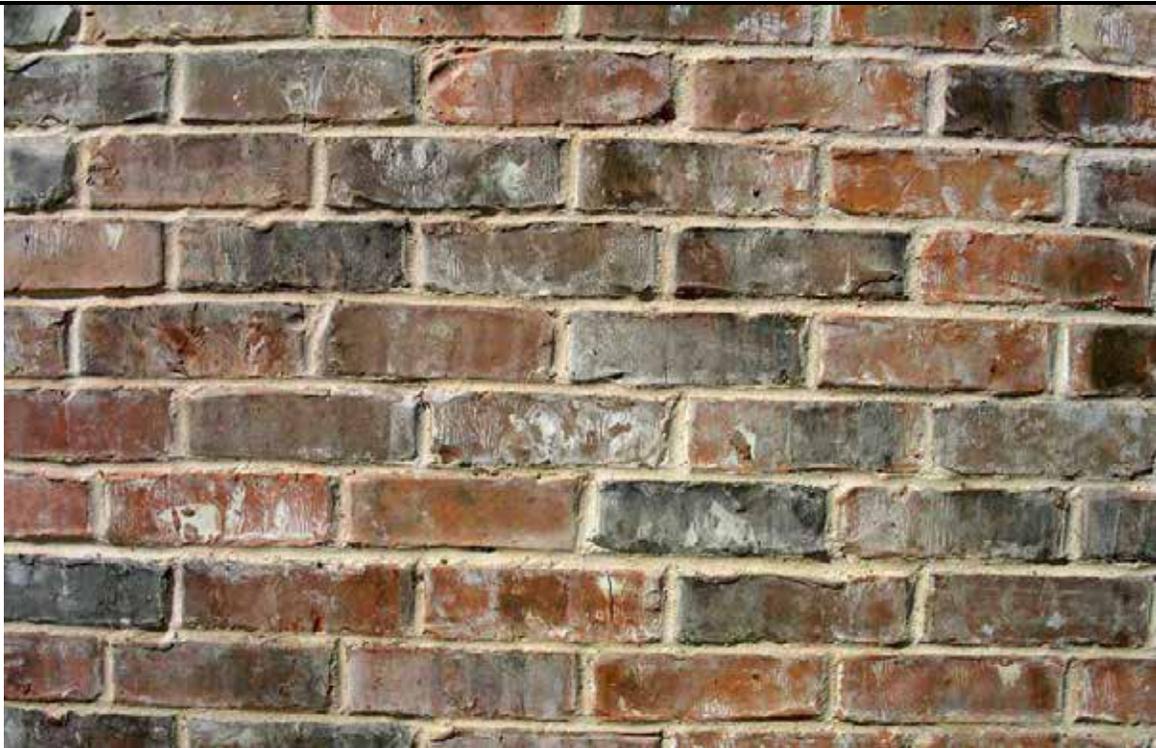
Figure 1. Brickwork with dryer cracks viewed five feet away.
At twenty feet they are not visible.

Dryer cracks or face cracks are normal in many brick blends and are a part of the distressed image of rusticated brick. They occur after brick are formed during the drying process and before they are fired. Dryer cracks are typically vertical and do not extend all the way through the brick. (See photos page 2.) The following questions and answers may help you better understand these occasional cracks when you see them:

Dryer cracks are not considered to be defects unless they exceed the limits of ASTM C652 Type HBA, which is the specification to which these brick were made. We do not accept any liability for the cost of filling those cracks or for any damage resulting from doing so.

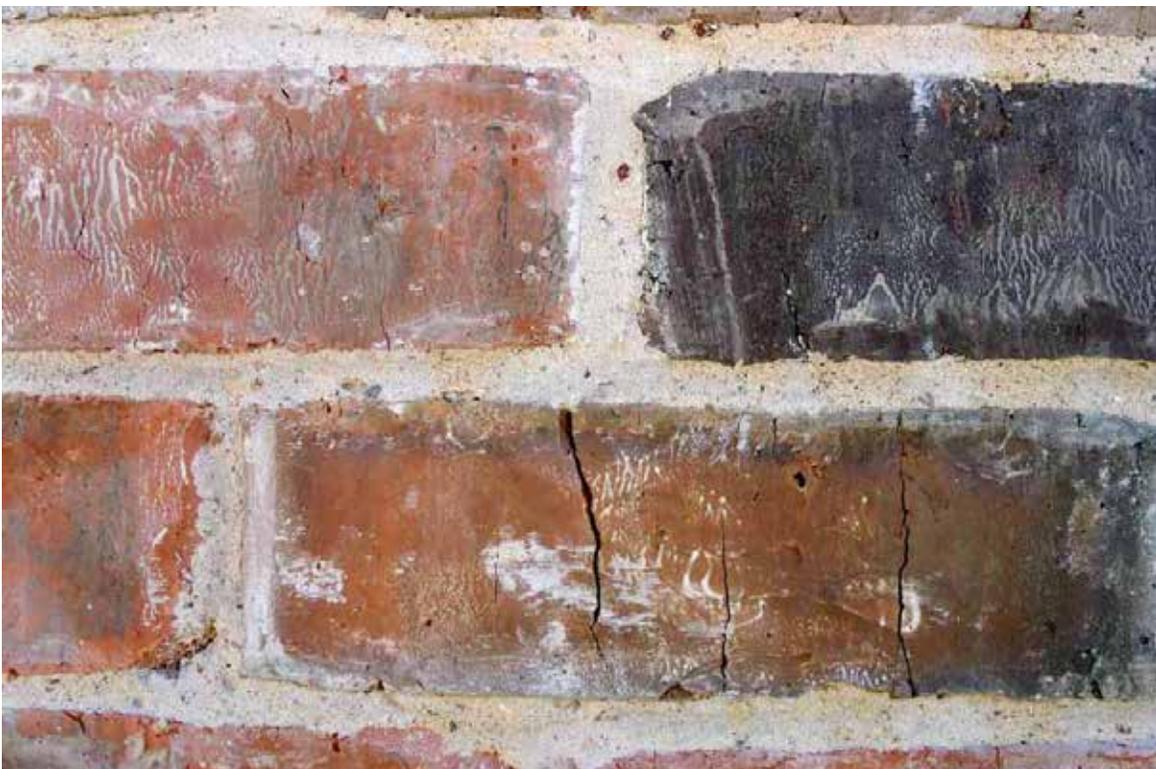
Figure 2. Close-up of a brick in that wall with dryer cracks.
